# ODI RESUME

**Investigation:** PE 16-007  
**Date Opened:** 06/28/2016  
**Investigator:** Kareem Habib  
**Approver:** Stephen Ridella  
**Subject:** Automatic vehicle control systems  
**Date Closed:** 01/19/2017  
**Reviewer:** Jeff Quandt

**Manufacturer:** Tesla Motors, Inc.  
**Products:** MY2014-2016 Tesla Model S and Model X  
**Population:** 43,781  
**Problem Description:** The Automatic Emergency Braking (AEB) or Autopilot systems may not function as designed, increasing the risk of a crash.

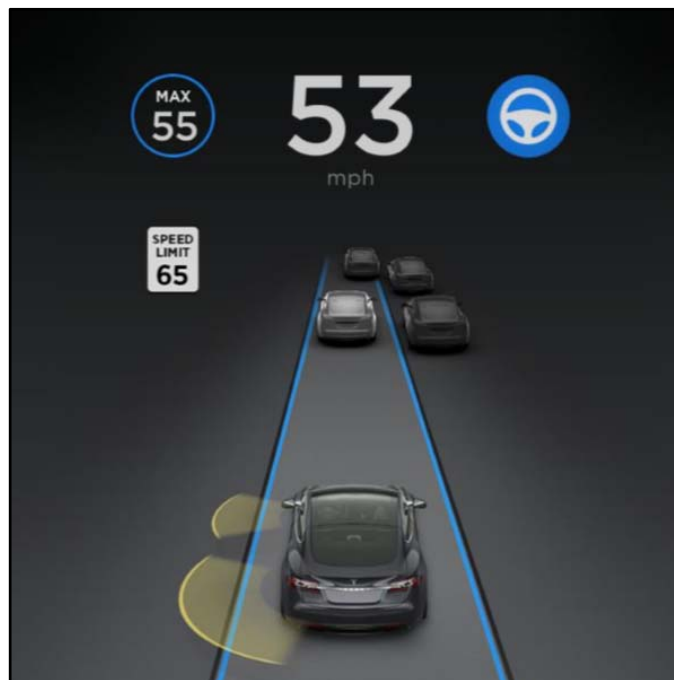
*Figure 5. Autopilot User Interface showing System Perceived Lane Lines, Other Vehicles, and Ultrasonic Objects.*

**4.2 System limitations.** Tesla provides information about system limitations at multiple levels, including: 1) the owner’s manual; 2) in the release notes for new software releases, which refer to the owner’s manual; 3) a user agreement required before enabling Autosteer for the first time or after an ignition cycle that concluded with Autosteer being switched off; 4) a dialog box that appears every time Autosteer is activated reminding the driver to “Always keep your hands on the wheel” and “Be prepared to take over at any time” (Figure 4); 5) the information in the user interface, which appears at all times while driving - the blue shaded circle around the white steering wheel indicates Autosteer is in operation, as opposed to when the background is gray meaning Autosteer is available should the driver decide to enable it (Figure 5).

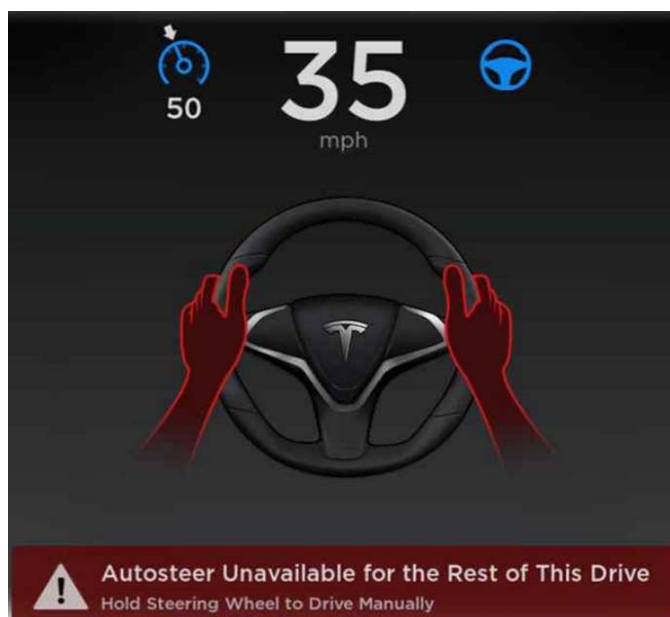
*Figure 6. Autosteer "Strike-Out" Alert.*

As part of Tesla's 8.0 over-the-air (OTA) software update in September 2016, Tesla revised the timing of the hands-on warnings and added a feature that takes away the Autopilot driving feature for the remainder of the drive cycle if the driver fails to respond to the alerts adequately (known as an "Autopilot strikeout" – Figure 6).

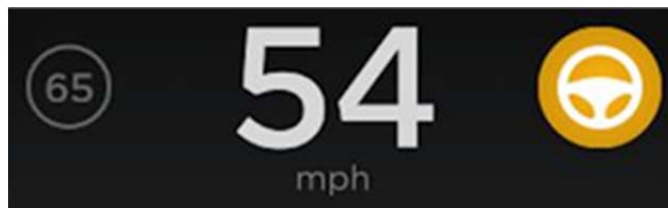
*Figure 1. Unsuccessful Autosteer Activation Alert.*

available, neither feature will activate and the Autosteer indicator icon will flash orange (Figure 7) and an audible alert will sound.
